Rimkus Consulting Group, Inc.
Eight Greenway Plaza, Suite 500
Houston, TX 77046
(800) 580-3228 Telephone
(713) 623-4357 Facsimile

Re: RCG File No: 11009971
LLV Number: 0209452
VMF Location: 1530 Greensmark Drive in Houston, Texas
Subject: Final Report

Rimkus Consulting Group, Inc. was retained to examine LLV 0209452, VIN 1GBCS10E4M2908832. The fire occurred on June 13, 2016 at around 12:30 P.M. the operator of the vehicle at the time of the fire, was unavailable for interview but reportedly stated the vehicle's engine died while delivering mail on his route and backfired during subsequent attempts to restart it. Soon thereafter, smoke was observed from beneath the hood as well as flames.

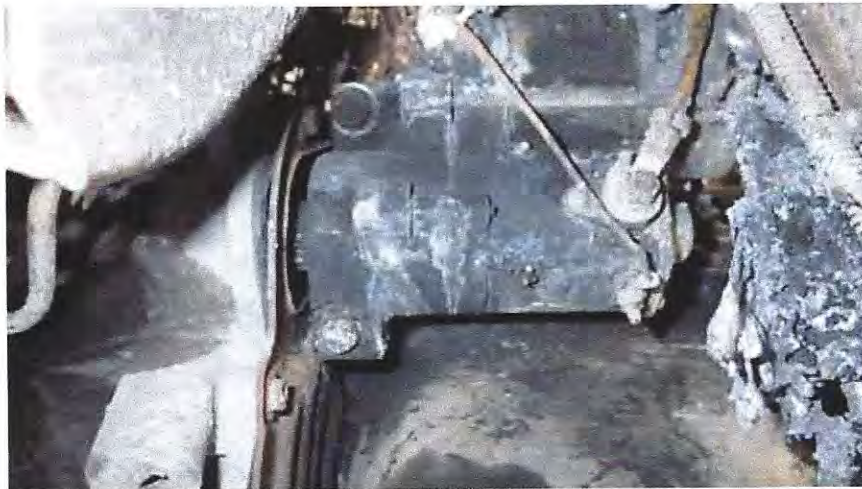
1. The area of origin for this fire was determined to be the engine compartment.
2. The point of origin was determined to be the starter.
3. The failure of the starter to disengage the flywheel caused it to run until it overheated, which ignited the oily residue. The flame extended out of the bell housing and ignited nearby wiring and combustibles.
4. After a complete investigation of this fire loss, Trident has determined this fire to be a mechanical failure.

View of the point of origin.

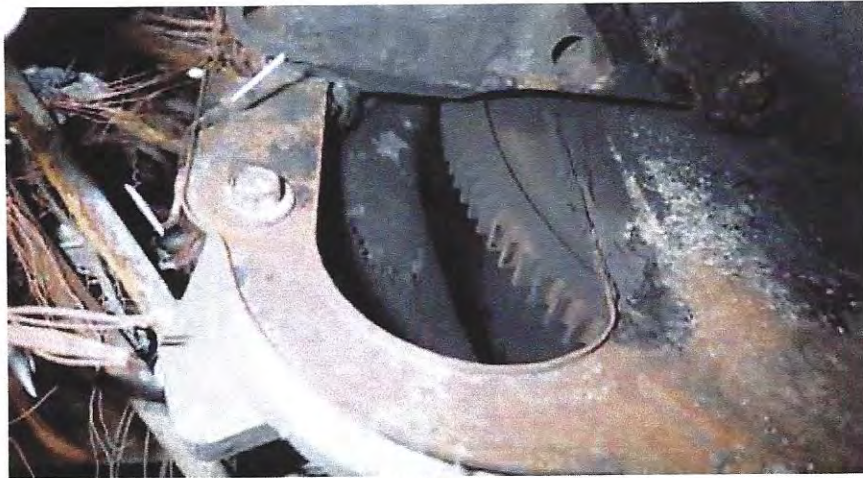
Close-up view of the point of origin.

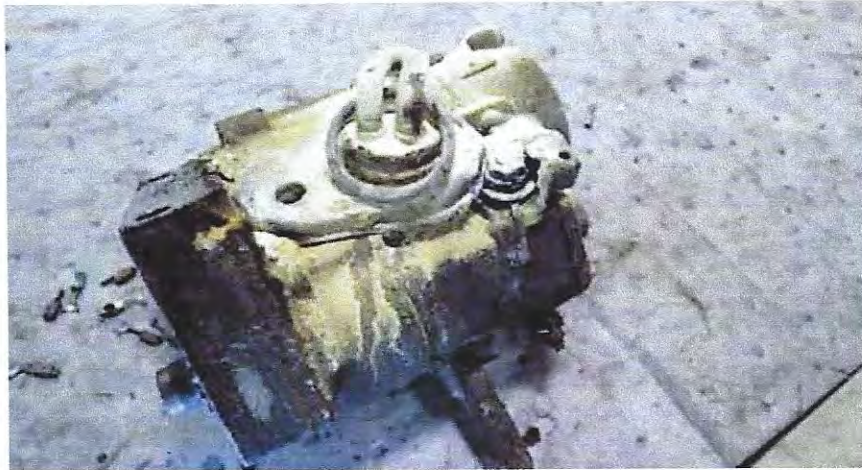
1. The origin of this fire is determined to be on the top of the starter solenoid.
2. The cause of this fire is determined to be the old style block heater being removed and dropped or left on top of the starter solenoid.
3. This action caused the metal block heater to wear away the rubber boot cover the positive terminal on the solenoid.

View of view of starter and solenoid after removal showing block heater fused to it.

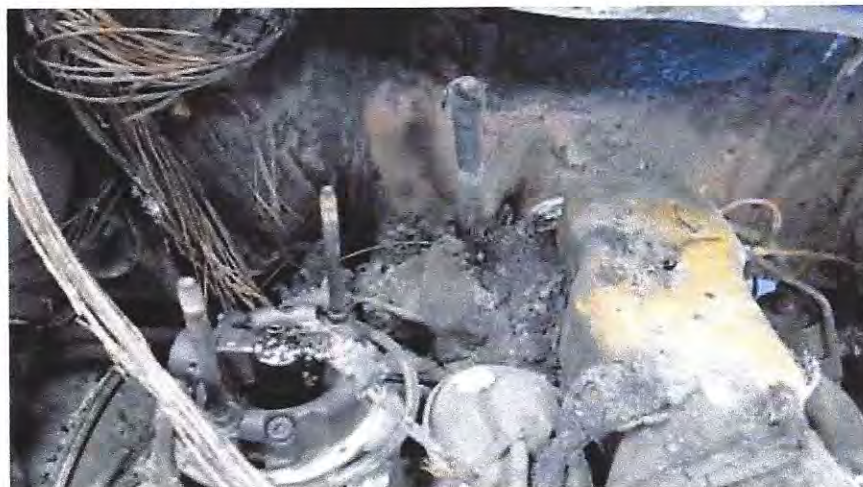
The examination of the fire damage revealed a fire occurred in the engine compartment. The fire extended from the carburetor and into the engine compartment. The carburetor had fuel moving through the system when the "back fire" occurred, igniting the unburned fuel, causing a quick flame. The fire damaged nearby combustibles and wiring.

1. The area of origin for this fire was determined to be the engine compartment.
2. The point of origin was determined to be the carburetor/throttle body.
3. The failure of the engine to run properly caused a backfire, which produced a flame that ignited nearby fuel. The flame extended out of the air cleaner to ignite nearby combustibles.
4. After a complete investigation of this fire loss, Trident has determined this fire to be a mechanical failure.

View of the point of origin.

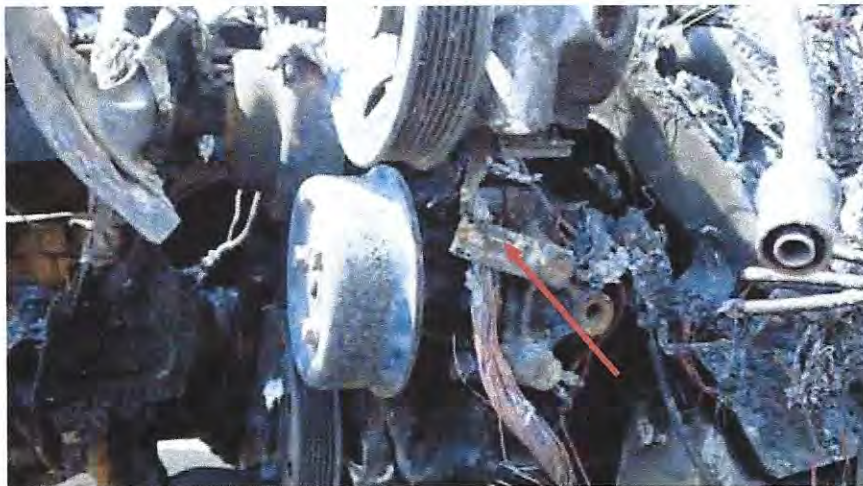
The examination of the fire damage revealed a fire occurred in the engine compartment. The fire extended from the positive battery cable and into the engine compartment. The positive battery cable became in contact with the metal bracket creating an arc. The transmission was leaking spraying fluid around in the compartment and to the rear causing it to ignite. The fire consumed the available nearby combustibles and wiring insulation.

1. The area of origin for this fire was determined to be the engine compartment.
2. The point of origin was determined to be the positive battery cable on the front left side of the engine compartment.
3. The positive battery cable contacted the metal bracket causing an arc which ignited nearby fuels (transmission fluid).
4. After a complete investigation of this fire loss, Trident has determined this fire to be a mechanical failure.

View of the point of origin.

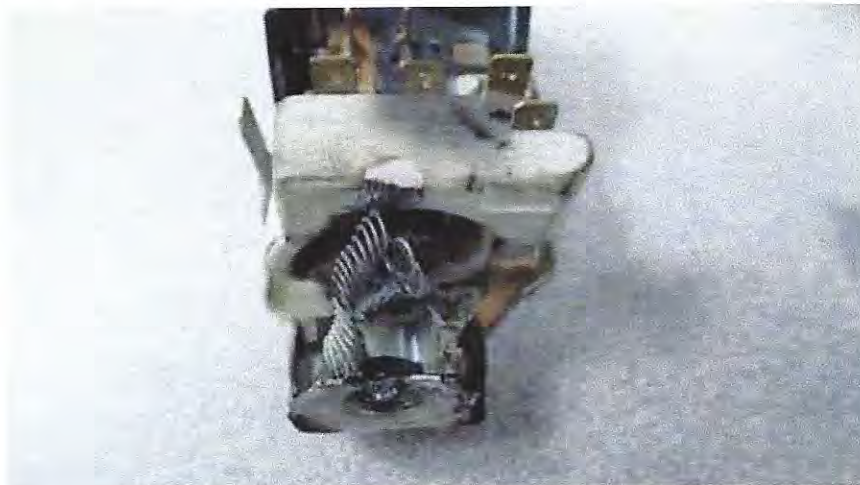
The examination of the fire damaged parts revealed a fire occurred in the passenger compartment. The fire appeared to have extended from the headlight switch to the instrument cluster. The fire may have damaged a nearby combustibles and wiring. A possible hypothesis for the cause of the fire may be the result of an electrical failure of the headlight switch. This is based upon the fire damaged parts that were examined from the LLV.

1. The area of origin for this fire was determined to be the passenger compartment.
2. The point of origin could not be determined due to the lack of information and the fact the LLV was repaired and returned to the branch.
3. A possible hypothesis for the cause of the fire was noted in the above discussion section.
4. Because there could be more than one possible hypothesis, the cause of the fire must be listed as undetermined.

View of headlight switch damage.

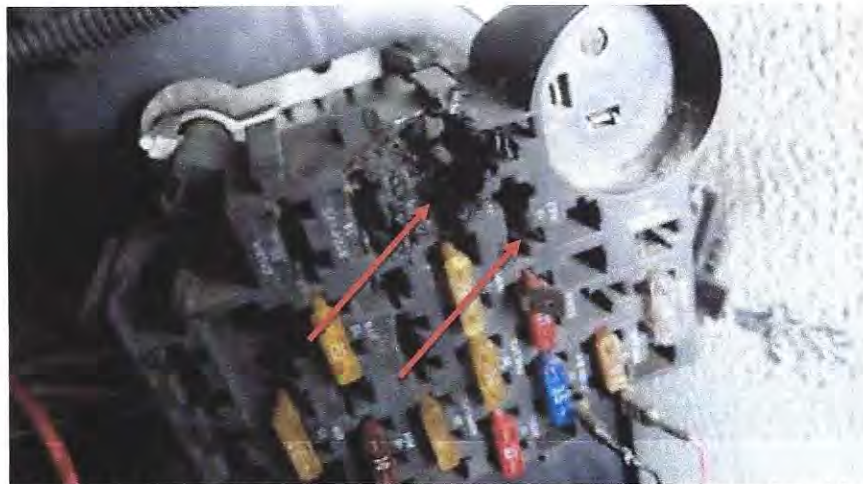
1. The area of origin for this fire is the fuse block, located under the dash on the right side of the operator.
2. The point of origin for this fire is the electrical feed connection to the hazard fuse on the rear of the fuse block.
3. The moving of the hazard fuse above and to the left of the original location occurred when the original location overheated and failed.
4. The cause of this fire is undetermined due to the original failure and subsequent second failure of the fuse connection being undetermined.

View of location of fuse at time of fire (left arrow) and original location (right arrow).

Trident recommends that the practice of moving fuses to a new location on the fuse block be stopped. These failures involve another unfound problem that causes the original location of the hazard fuse to fail. The replacement of the fuse block and wire harness may solve the problem. An analysis of the amperage load of the new style strobe lights should occur to determine if one 15 amp fuse is sufficient as well as the required wire size that is feeding these lights is sufficient to prevent reoccurring overheating.

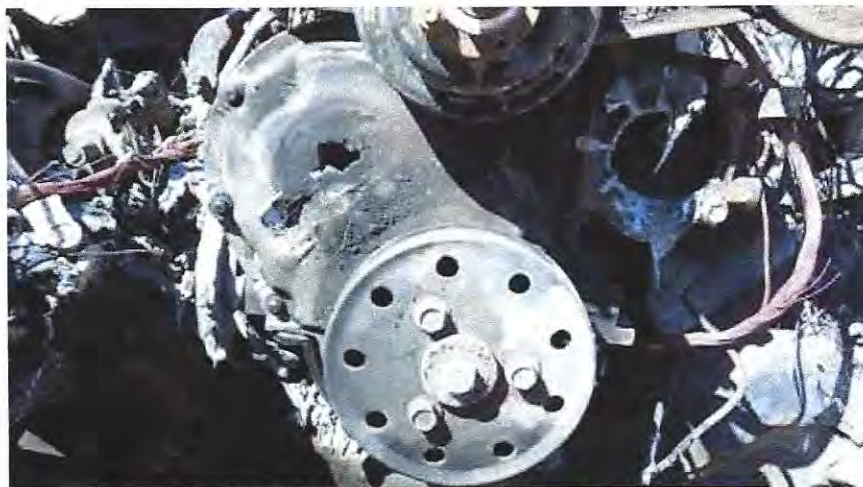
The main engine wiring harness was partially consumed by direct fire attack. A possible hypothesis for the cause of the fire may be the result of the hole in the timing chain cover on the right front of the engine this would allow engine oil to be sprayed on hot surfaces of the engine. It would also support witness statement of an odor of burning oil. There was oily residue found throughout the engine compartment. A hot surface ignition from leaking engine oil could not be ruled out as a possible ignition scenario.

1. The area of origin for this fire was determined to be the engine compartment.
2. The point of origin could not be determined due to the lack of information and extensive fire damage.
3. A possible hypothesis for the cause of the fire was noted in the above discussion section.
4. Because there is more than one possible hypothesis, the cause of the fire must be listed as undetermined.

View of the timing chain cover.

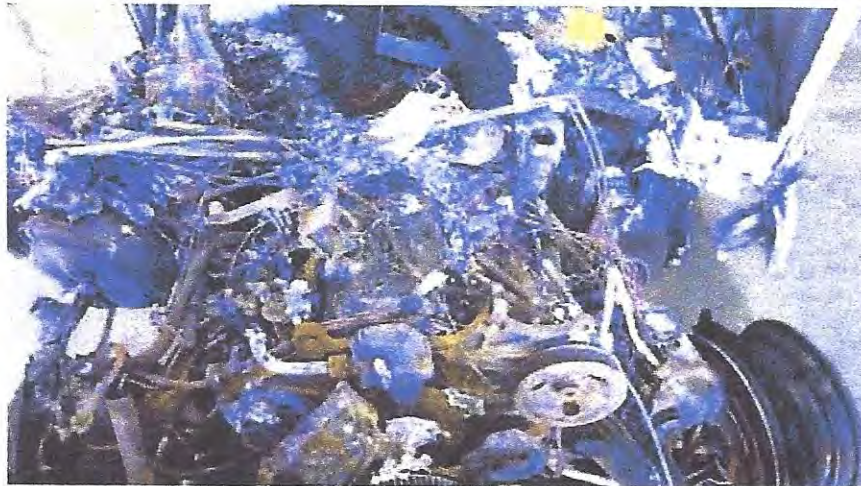
Examination of this fire loss has determined the fire originated in the area of the bulkhead within the engine compartment. This determination is based upon the observations of [REDACTED] and the noted fire patterns on the vehicle. It should also be noted that with the extensive fire damage to this vehicle [REDACTED]'s time frame of slightly more than five minutes is not enough burn time for the damage noted.

1. The area of origin for this fire was determined to be the right side of the bulkhead within the engine compartment.
2. With the extensive fire damage to this vehicle, a point of origin or first material ignited could not be determined.

View of engine.

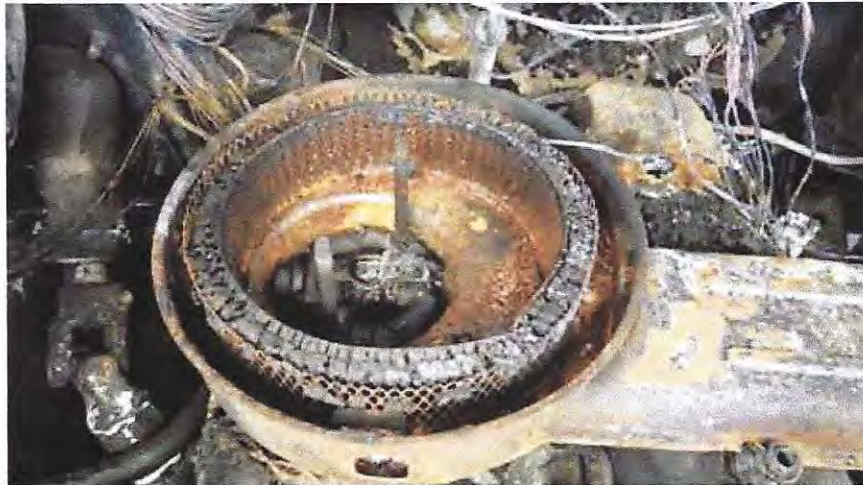
The examination of the fire damage revealed a fire occurred in the engine compartment. The fire extended from the carburetor and into the engine compartment. The carburetor had fuel moving through the system when the "back fire" occurred igniting the unburned fuel causing a flame. The fire damaged nearby combustibles and wiring.

1. The area of origin for this fire was determined to be the engine compartment.
2. The point of origin was determined to be the carburetor.
3. The failure of the engine to run properly caused a back fire, which produced a flame that ignited nearby fuel. The flame extended out of the air cleaner to ignite nearby combustibles.
4. After a complete investigation of this fire loss, Trident has determined this fire to be a mechanical failure.

View of Point of Origin.

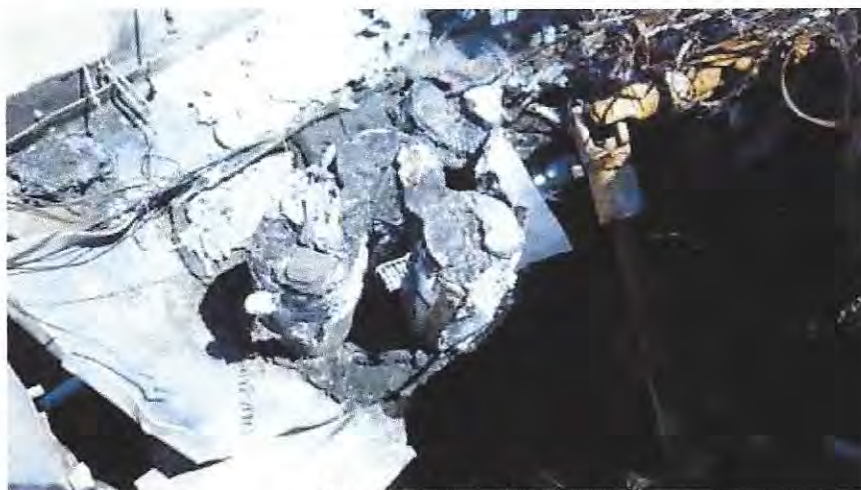
The main engine wiring harness was partially consumed by direct fire attack. A possible hypothesis for the cause of the fire may be the result of a battery failure. It would also support witness statement of trying to restart the vehicle several times with negative results then seeing smoke.

An electrical ignition from a battery failure could not be ruled out as a possible ignition scenario.

View of the battery.

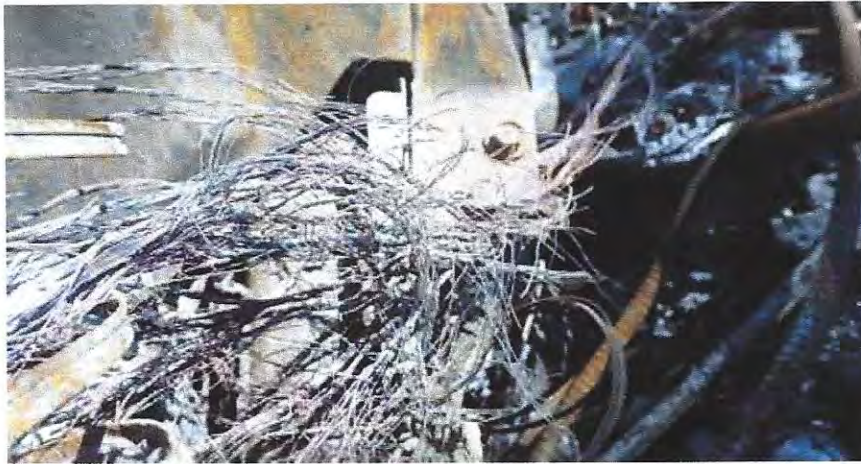
View of the remaining wire for fuse block.

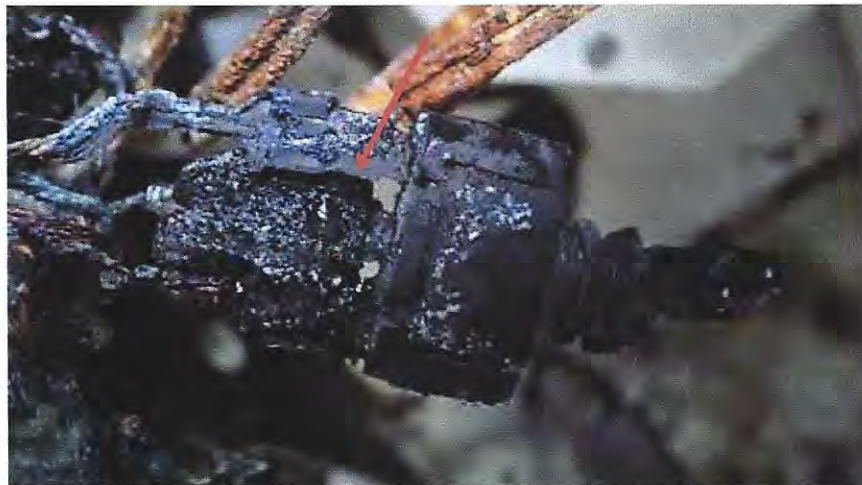
A complete investigation of this fire determined the fire to have originated at the power feed connection for the flasher switch. This failure is the result of a poor connection. This poor connection would have caused the improper operation of the switch. This failure reiterates the need for all electrical connections to be examined and replaced as needed during the maintenance program.

1. The area of origin for this fire was determined to be the right side of the dash within the operators' compartment.
2. The point of origin for this fire was determined to be a failure of the wire connection at the flasher switch.
3. The failure of this connection reinforces the need for examination of all electrical connections.

View of flasher switch connections showing evidence of electrical arcing.

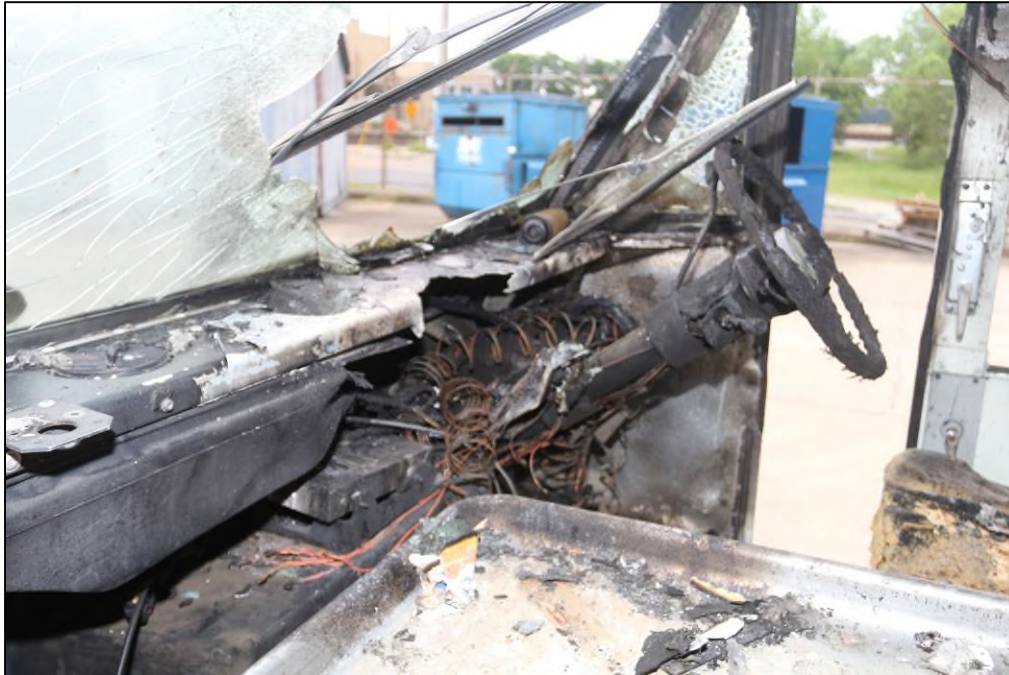
Photograph 7

Area of origin, looking from passenger to driver side.

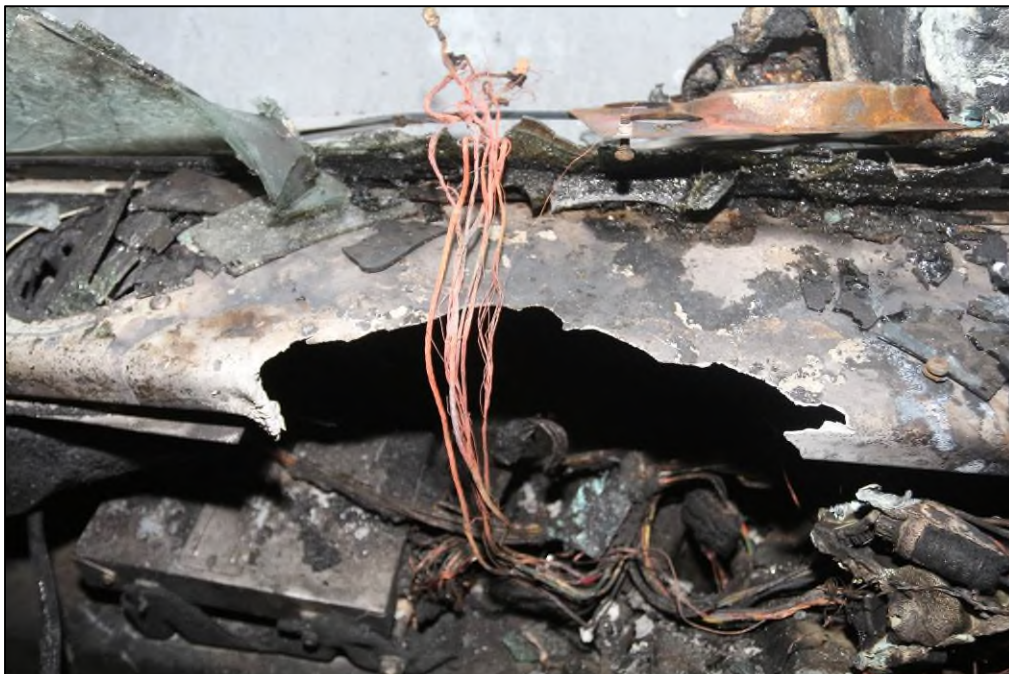
Photograph 10
Area of origin.
